#### **VALDEZ NEW BOAT HARBOR PHASE 1 - UPLANDS**

CONSTRUCTION PROGRESS REPORT No. 14
AUGUST 3, 2015 – AUGUST 9, 2015

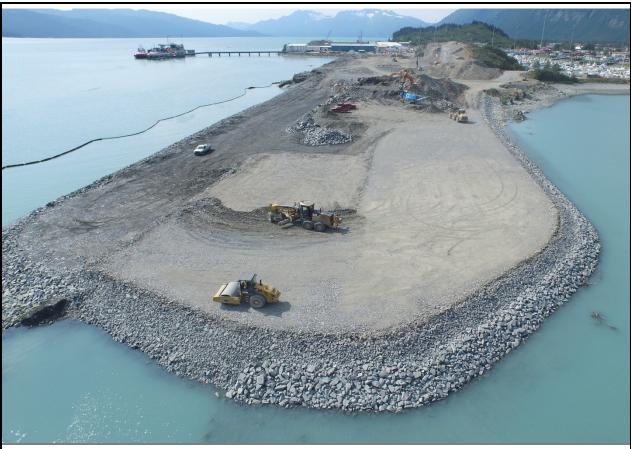
View West. East fill is being constructed with 12" lifts of processed material above 10' elevation, with filter rock and riprap placed on the slope. Grader spreads and vibrator roller compacts each lift. (by J. Talbott, COV)

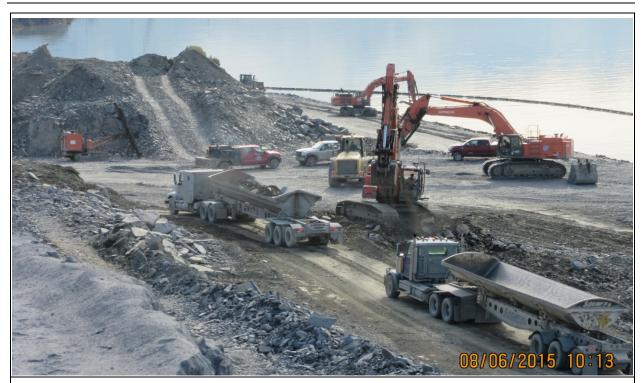
View East. Last of mass excavation in process near east end of Hotel Hill. Loading side dumps with overburden (front) for hauling to City C&D Pit. Crusher beyond mound at upper left. South edge of east fill at upper right.

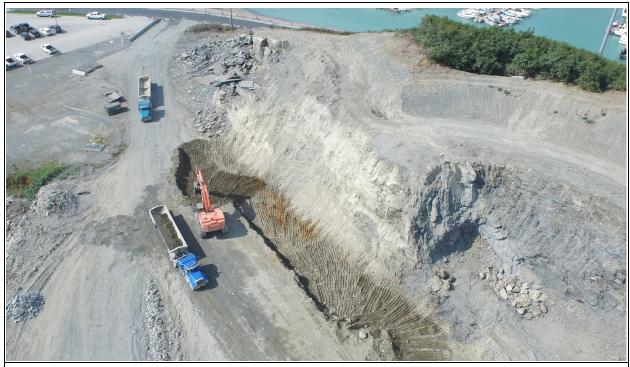
View Northwest. Excavating frost-susceptible soil 4' below subgrade near future west entrance. The wash down pad, also in this area, was excavated 8' below subgrade. Scaling top of the slope at lower right (J. Talbott, COV)
